Pore-pressure generation and fluidization in a loess landslide triggered by the 1920 Haiyuan earthquake, China: A case study

During the 1920 Haiyuan earthquake, numerous catastrophic landslides were triggered in the loess area in Northwest China. We investigated in detail a large example of these landslides, referred to as Dangjiacha landslide in this paper. This landslide originated from a slope of about 20°, and the displaced soil mass traveled about 3200 m, damming a valley. We performed a field survey and found that standing water existed in the landslide area and the loess had high porosity. We infer that it was the liquefaction of the water-saturated loess layer rather than the suspension of silt in the pore-air in the loess that caused the great mobility of this landslide. To test this inference, we performed undrained triaxial compression and ring shear tests on loess samples to examine the shear behavior of loess saturated by either air or water. The test results showed that the water-saturated loess soil was highly susceptible to flow liquefaction failure. Fast shear tests on naturally air-dried loess samples revealed that the generated pore-air pressure was small under

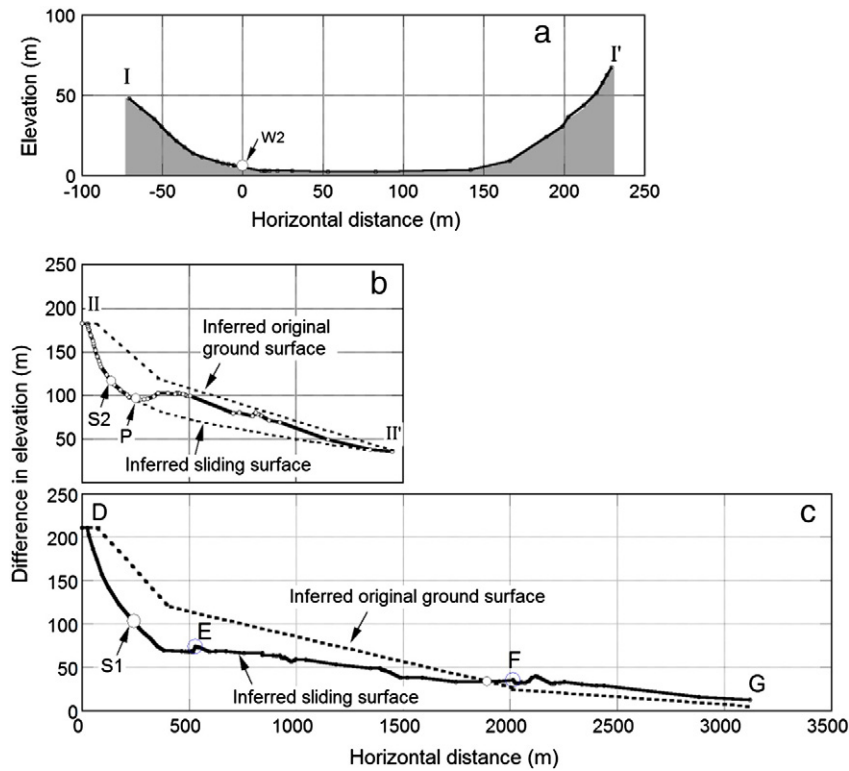
Fig. 4. Cross section along Line I-I'. (a), longitude section along Line I-I-II' (b) and Line D-E-F-G (c) in Fig. 2, respectively.

(from the cross section along I–I' shown in Figure 4a), and the slope angle (θ) of 20° , we estimate that the shear stress acting on the potential sliding surface ($\tau = H\gamma_d \sin\theta \cos\theta$) before the sliding was about 180 kPa. This initial shear stress and the in-situ void ratio will plot above the steady-state line shown in Fig. 15. Hence, once shear failure occurred during the earthquake, the shear resistance of the water saturated loess layer near the sliding surface would drop to a very small value due to liquefaction, and then the great difference between the driving shear stress and the lowered shear resistance would result in the accelerating movement of displaced landslide materials.

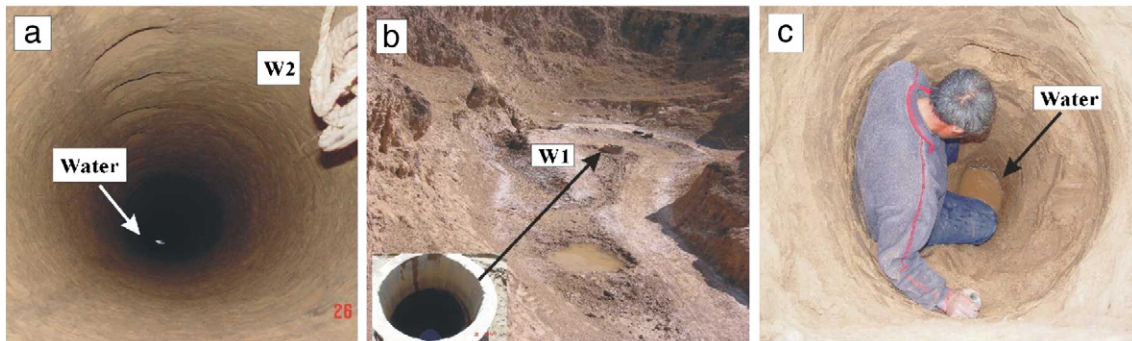
Fig. 5. Wells located in the right (a) and left (b) sliding blocks and the investigation pit (c) near the well W1.

We observed standing water (Figure 5) and shallow groundwater (Points W1 and W2 in Figure 2) in the landslide source areas, even 80 years after the 1920 earthquake. Point W2 references a well that supplies water for several families, with a water table 22 m (measured on March 26, 2003) below the present ground surface. We were told that the groundwater table in W2 was usually higher during summer. Well W1 is very shallow. To examine the aquifer location, we dug a pit near W1 on March 20, 2005, and found groundwater at a depth of about 2 m (Figure 5c).

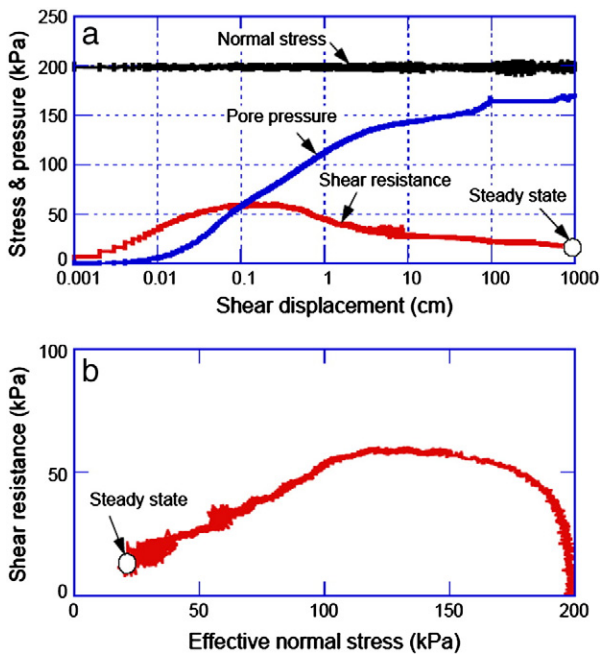
Fig. 11. Undrained response of water-saturated loess sample to monotonic shearing. (a) Normal stress, shear resistance and pore-water pressure versus shear displacement; (b) effective stress path ($e = 1.06$).

The results of a test on a water-saturated loess sample with initial void ratio of 1.06 are shown in Fig. 11, where normal stress, pore-water pressure, and shear resistance are plotted against shear displacement (Figure 11a). Fig. 11b shows the effective-stress path. It is noted that pore pressures are measured by pore pressure transducers connected to a gutter (4×4 mm) located along the entire circumference of the inner wall of the outer ring in the upper cylinder pair of the specimen chamber, 2 mm above the shear surface. More details on the pore-water pressure monitoring system can be found in Sassa et al. (2003). From Fig. 11a, it can be seen that the pore-water pressure increased with increasing shear displacement before reaching a great value (about 85% of the applied normal stress), while shear resistance decreased to a small, nearly constant value (about 10 kPa) after about 1000 cm of shear displacement; hence, steady-state resistance was reached.

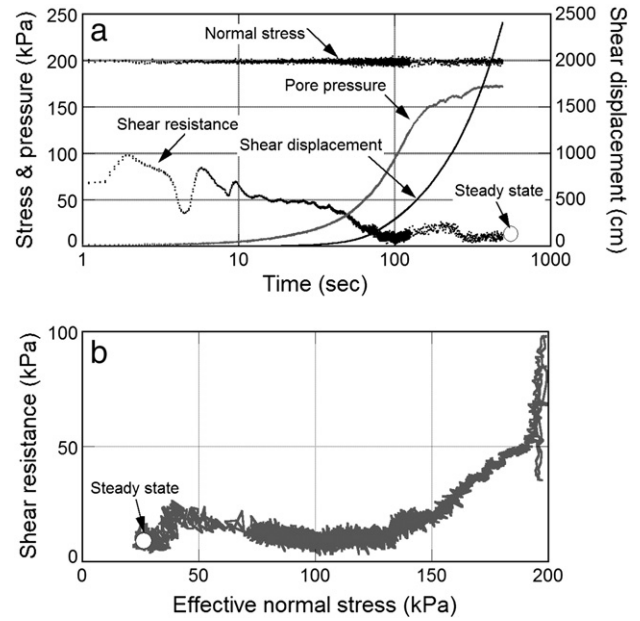
Fig. 12. Undrained response of water-saturated loess sample to cyclic loading in ring shear test. (a) Time series data of normal stress, shear resistance, pore-water pressure and shear displacement; (b) effective stress path ($e = 0.99$).

Cyclic loading tests were also conducted on a water-saturated loess sample. After saturation, the sample was consolidated under a normal stress of 200 kPa while a shear stress of 80 kPa was applied. After consolidation, a cyclic shear loading was applied under undrained conditions with an amplitude of 60 kPa and a frequency of 0.25 Hz, while the normal stress was kept constant. Fig. 12 presents the test results in the form of time-series data of normal stress, shear resistance and pore-water pressure (Figure 12a), and in the form of the effective stress path (Figure 12b). Shear failure was triggered during the first cycle and pore-water pressure increased continuously thereafter, while shear resistance decreased until reaching a small, constant value (about 7.6 kPa). It is noted that the measured shear resistance before the occurrence of shear failure represented the applied shear loading, but after failure shear loading greater than the shear resistance of soil could not be applied (Wang et al., 2007). Hence, the intended amplitude of the cyclic loading is not apparent in Fig. 11, although the frequency of the applied cyclic loading is. From Figs. 11 and 12, it can be concluded

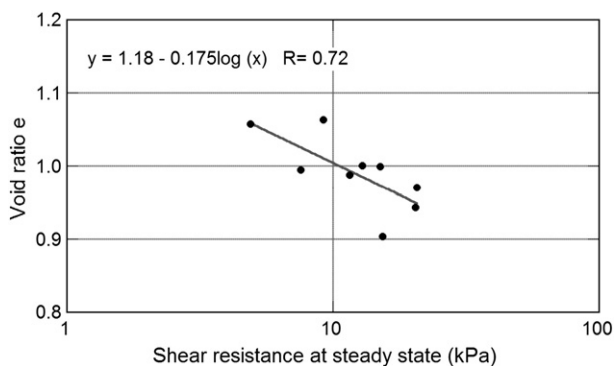
Fig. 15. Shear resistance at steady state versus void ratio for water-saturated loess samples.

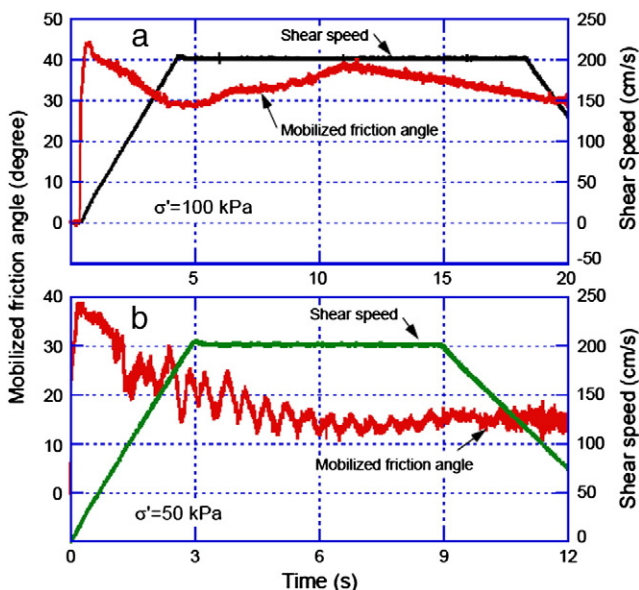
Fig. 17. Results of tests on air-dried loess samples that were consolidated under the initial stress of (a) 100 kPa ($e = 1.42$), and (b) 50 kPa ($e = 1.43$), respectively.

From Fig. 17, we can conclude that increased pore-air pressure would have less effect on the mobility of deep-seated landslides because the reduction of effective normal stress from elevated pore-air pressure

is negligible when the normal stress is large (i.e., the landslide thickness is great). Moreover, it is worth noting that the test shown in Fig. 17b was performed under an idealized undrained condition. In the field condition, high permeability of soil with large pore spaces and abundant cracks may enable the quick dissipation of generated air pressure. Hence, any shear-induced generation of air pressure in the field would be smaller than in the laboratory to the extent that its contribution to the high mobility of shallow landslides may be ignored.
